The Road Inventory of Harris Neck National Wildlife Refuge Townsend, GA

Prepared By:
Federal Highway Administration
Central Federal Lands Highway Division
November, 2011

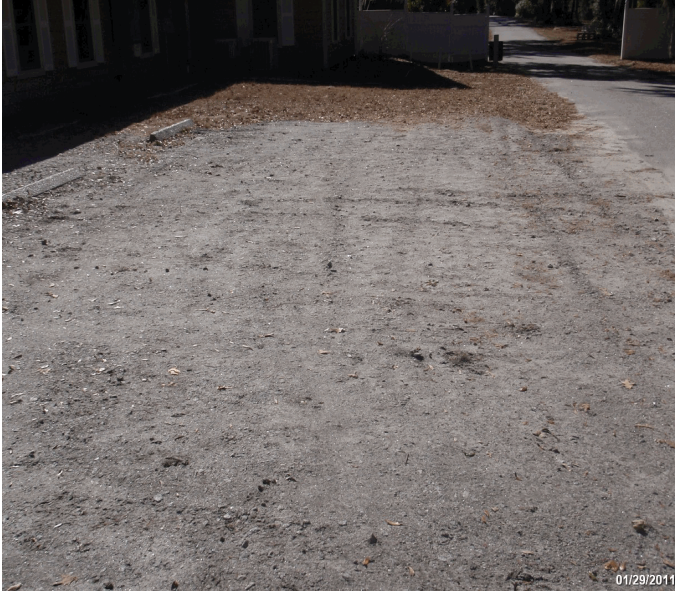
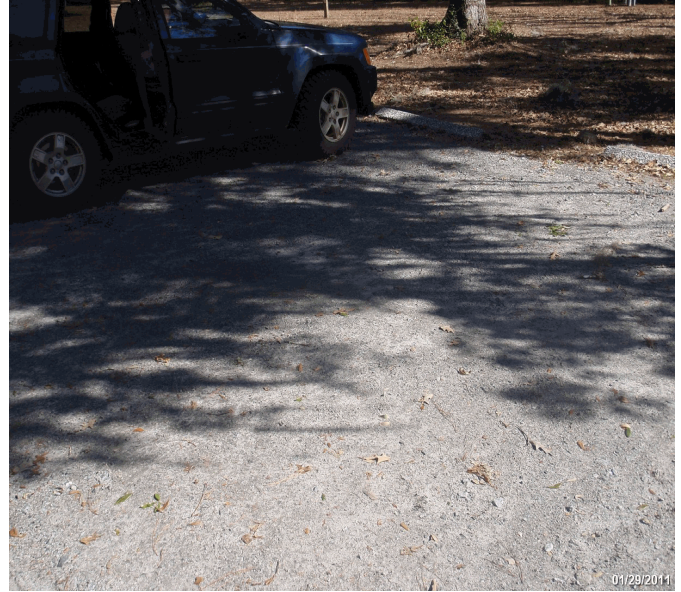
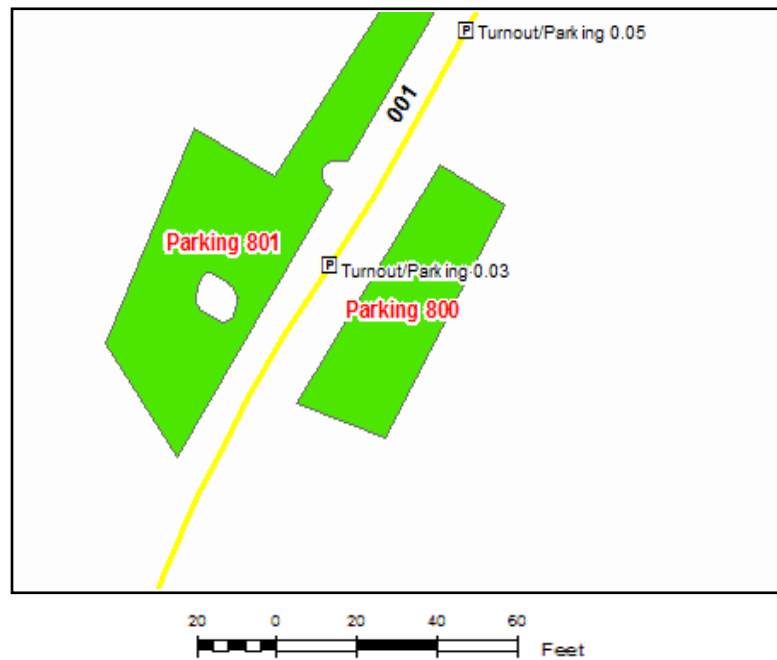
800: Headquarters Staff Parking

Asset Number	Date Visited	Surface Type	Area (Sq Ft)	Condition	Cost to Improve
10054748	01/29/2011	Gravel	1,798	Good	300

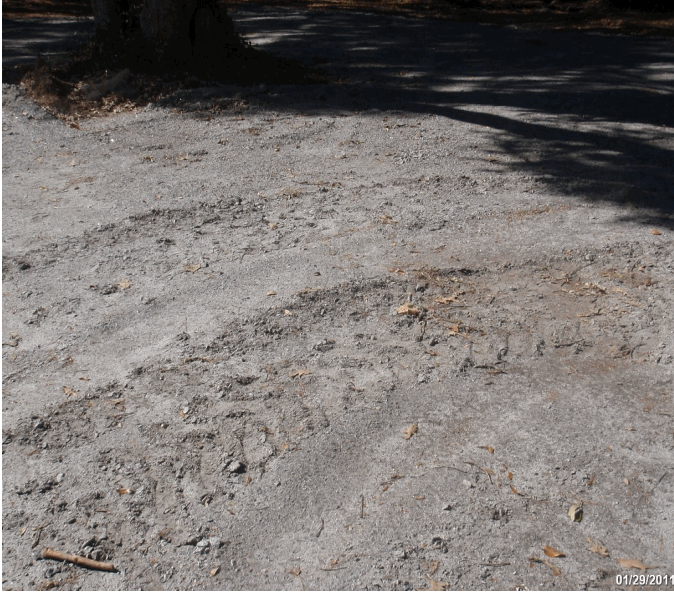
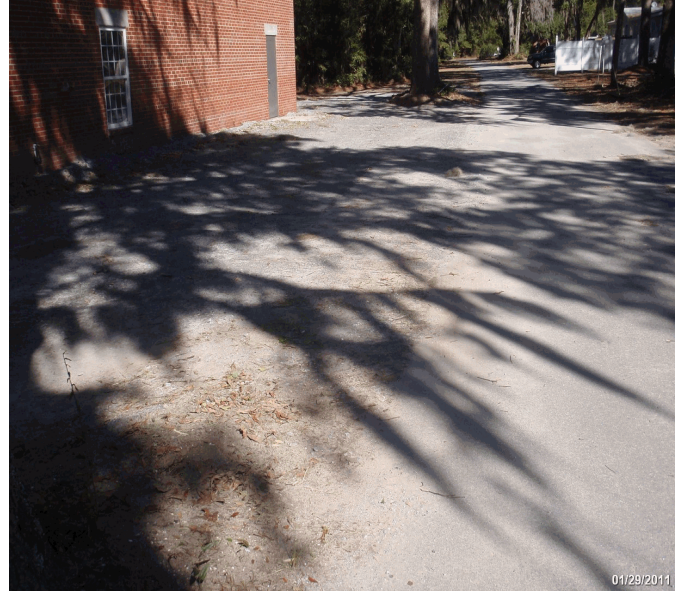
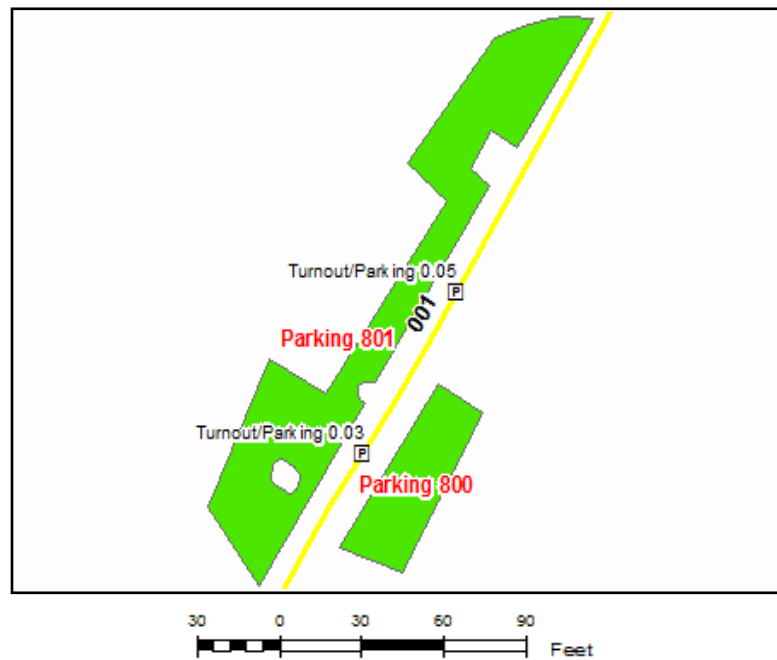
801: Shop Parking

Asset Number	Date Visited	Surface Type	Area (Sq Ft)	Condition	Cost to Improve
	01/29/2011	Gravel	6,155	Good	900

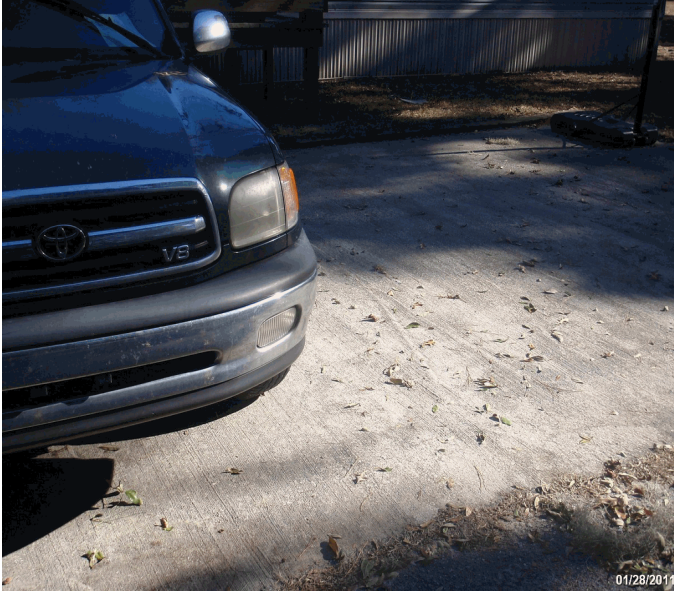
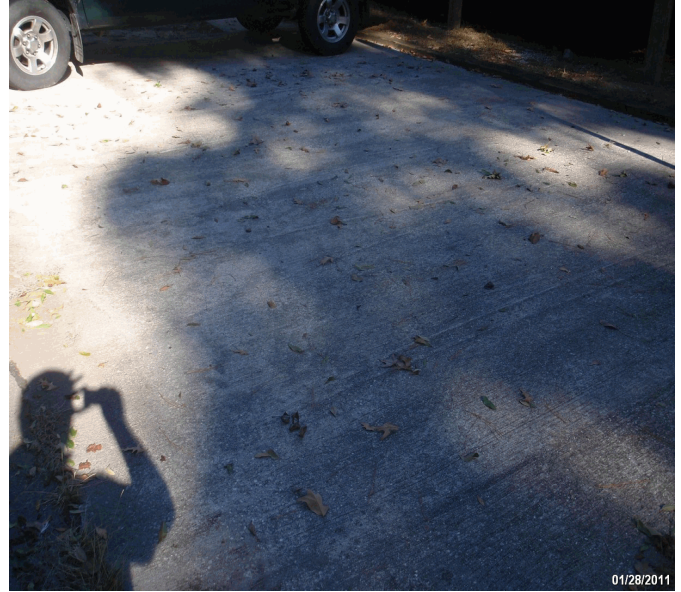
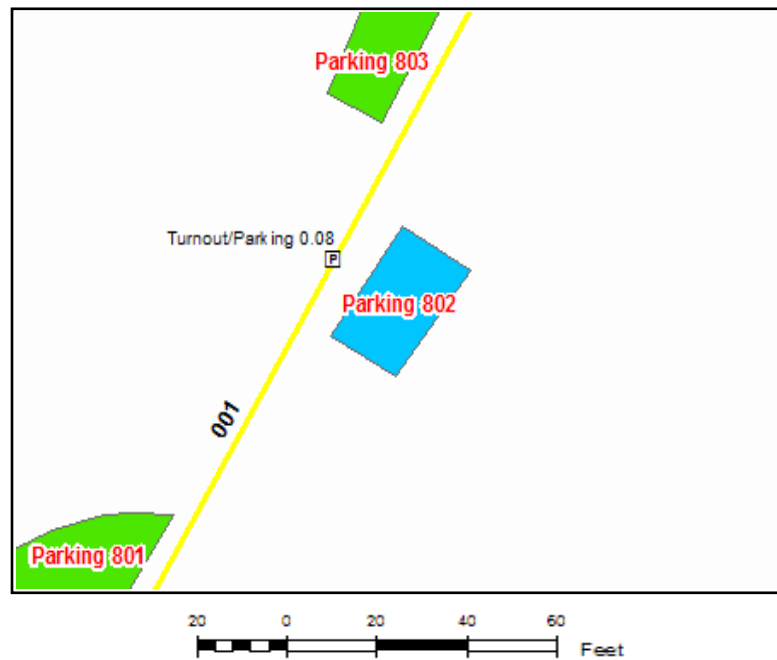
802: East LE Quarters Parking

Asset Number	Date Visited	Surface Type	Area (Sq Ft)	Condition	Cost to Improve
10037393	01/28/2011	Concrete	623	Excellent	0

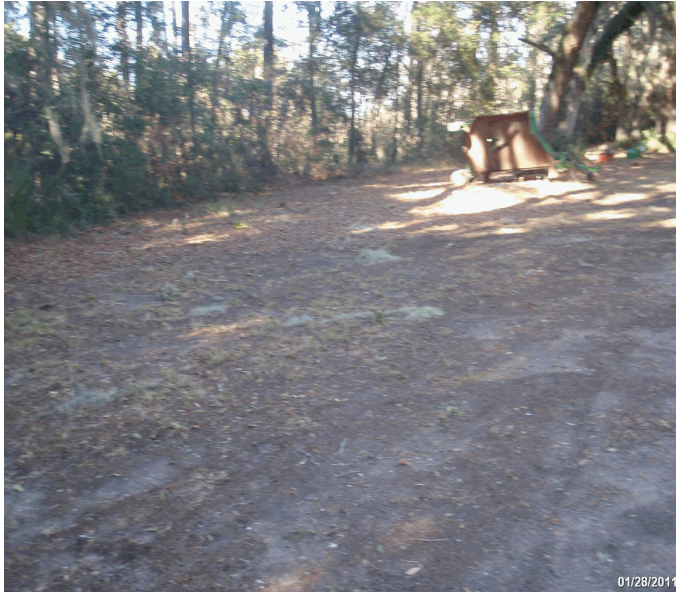
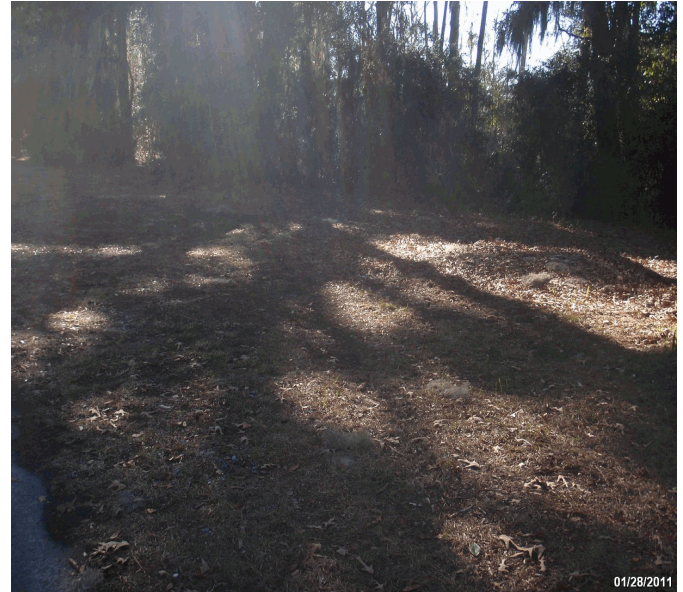
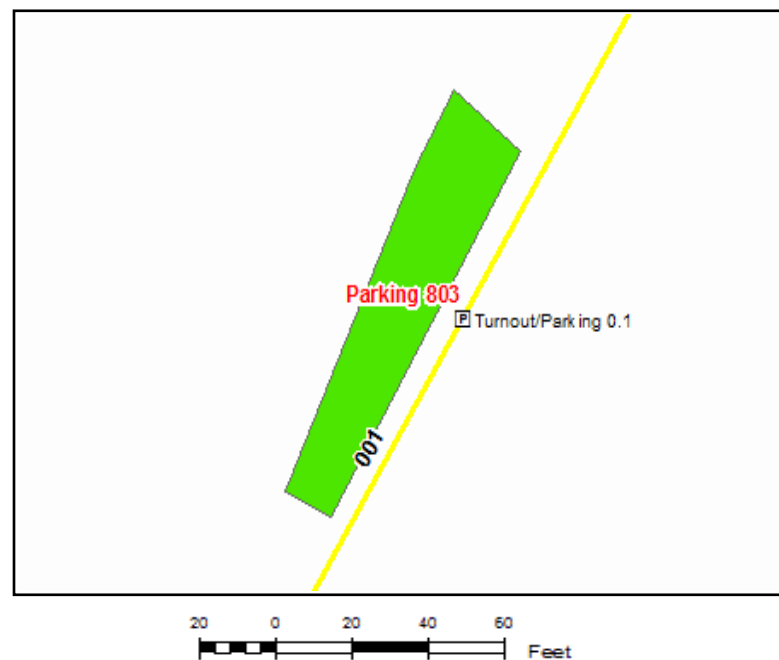
803: West LE Quarters Parking

Asset Number	Date Visited	Surface Type	Area (Sq Ft)	Condition	Cost to Improve
10037394	01/28/2011	Native	2,555	Good	400

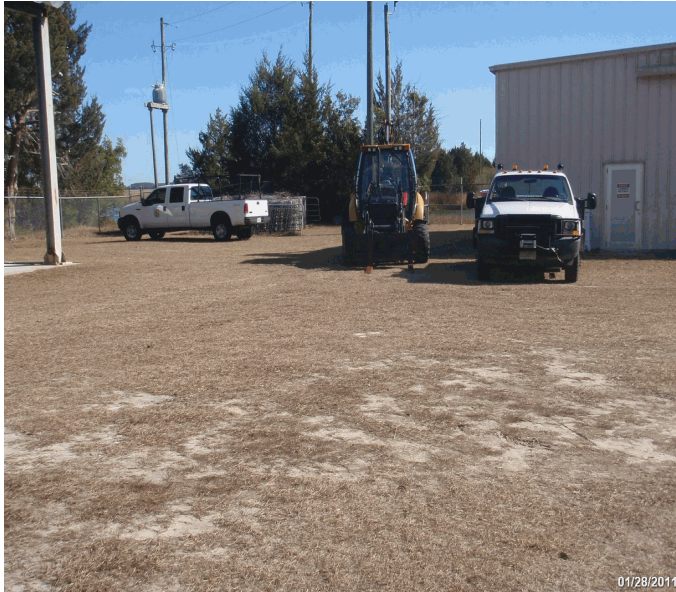
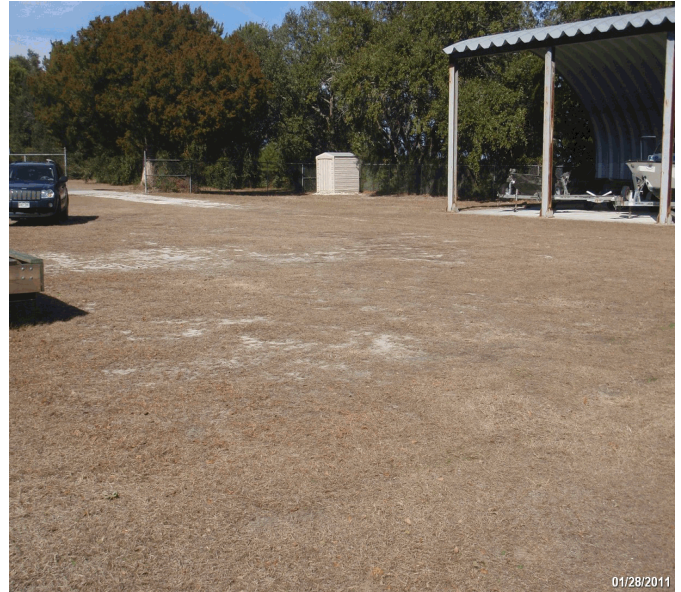
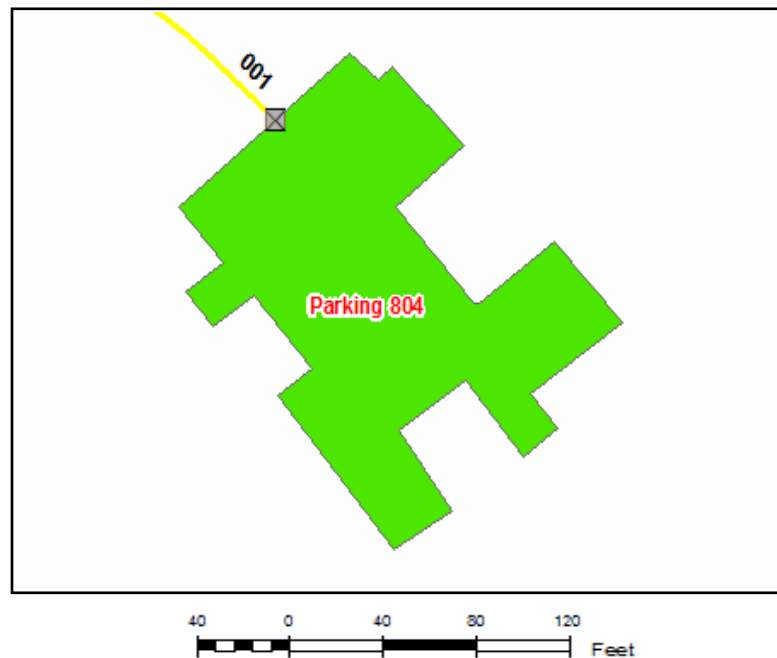
804: Boat House Area Parking

Asset Number	Date Visited	Surface Type	Area (Sq Ft)	Condition	Cost to Improve
	01/28/2011	Native	21,567	Good	3,000

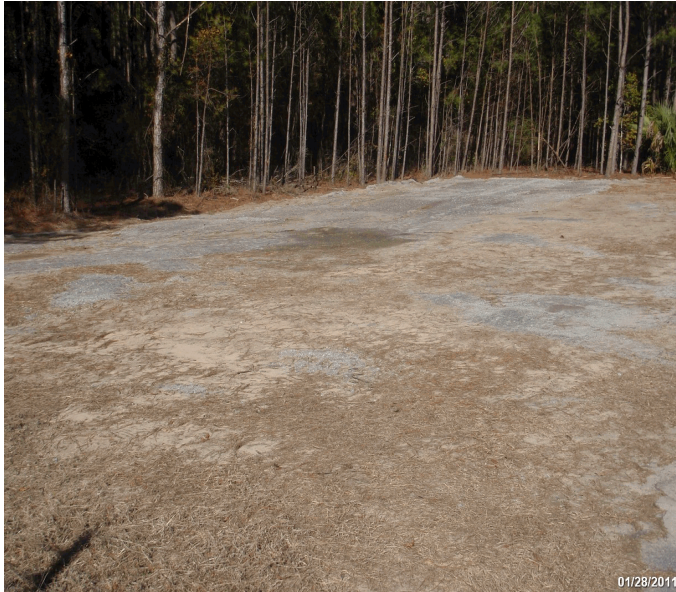
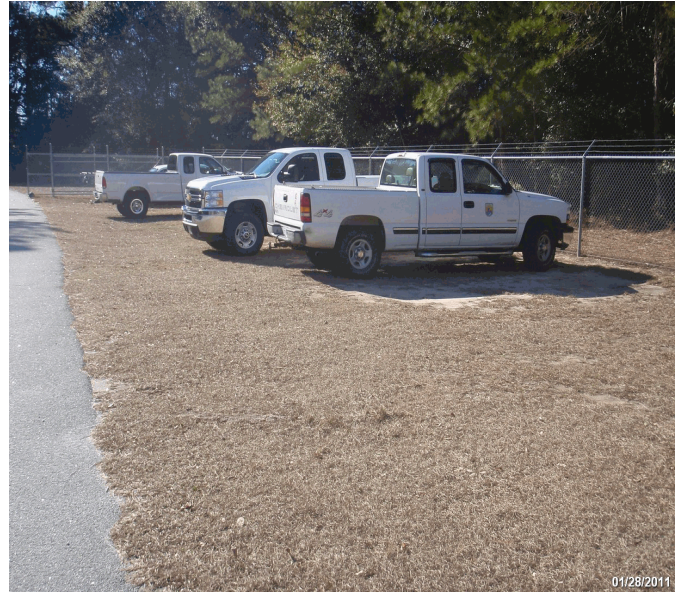
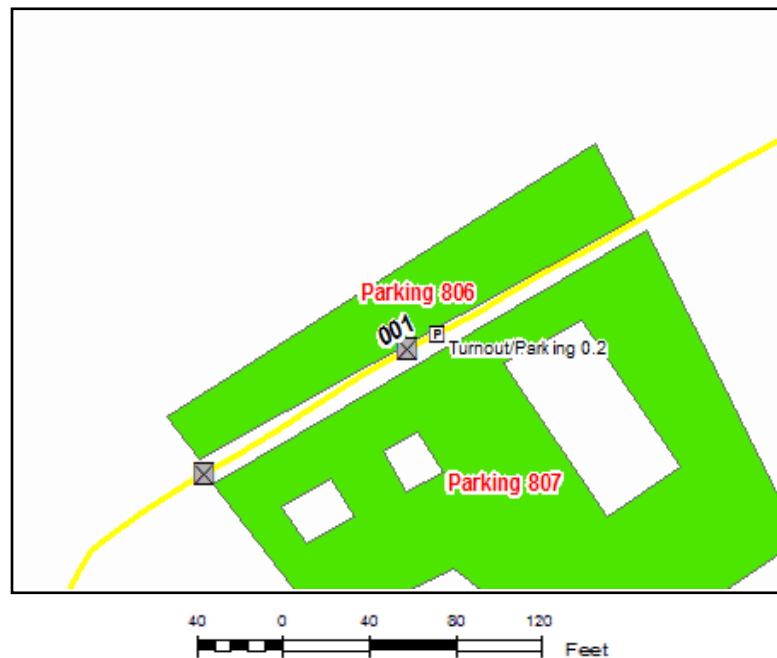
806: East Maintenance Parking

Asset Number	Date Visited	Surface Type	Area (Sq Ft)	Condition	Cost to Improve
	01/28/2011	Native	9,150	Good	1,300

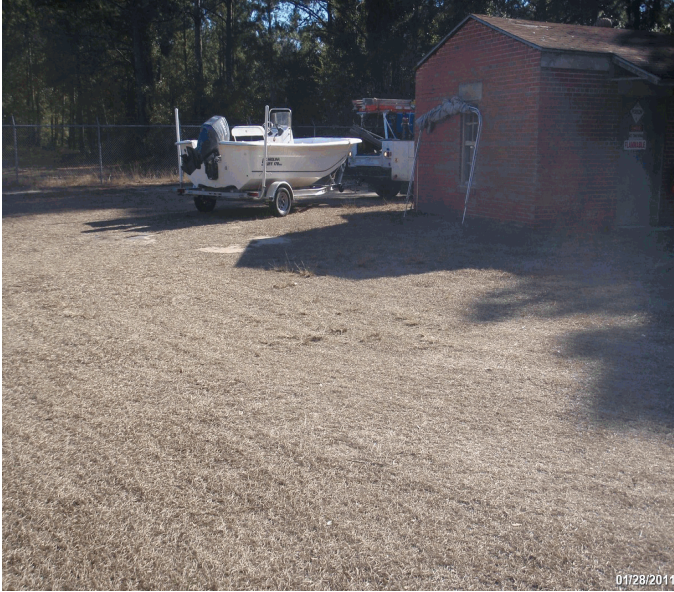
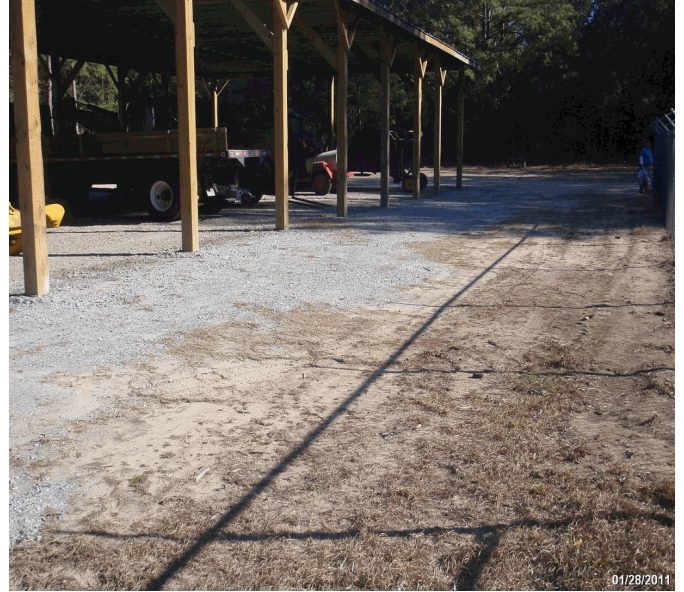
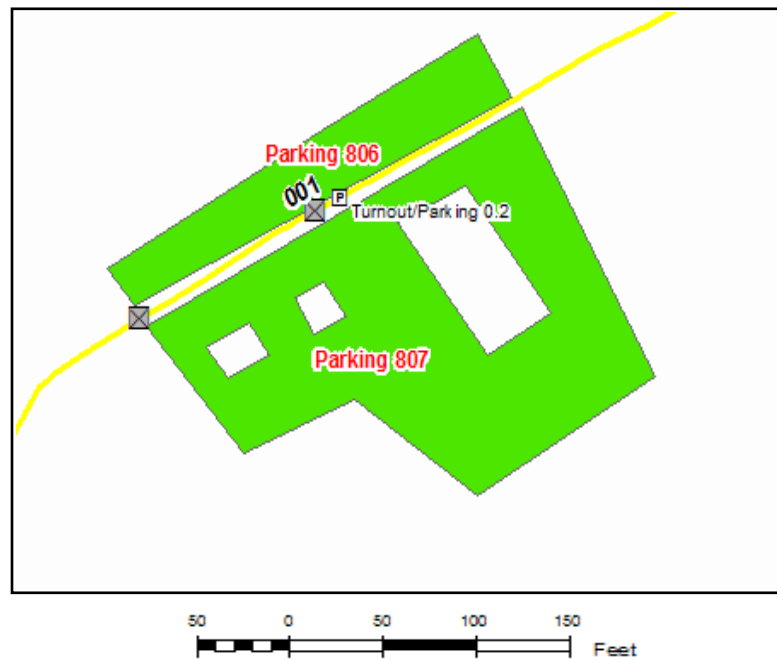
807: West Maintenance Parking

Asset Number	Date Visited	Surface Type	Area (Sq Ft)	Condition	Cost to Improve
	01/28/2011	Native	31,579	Good	4,400

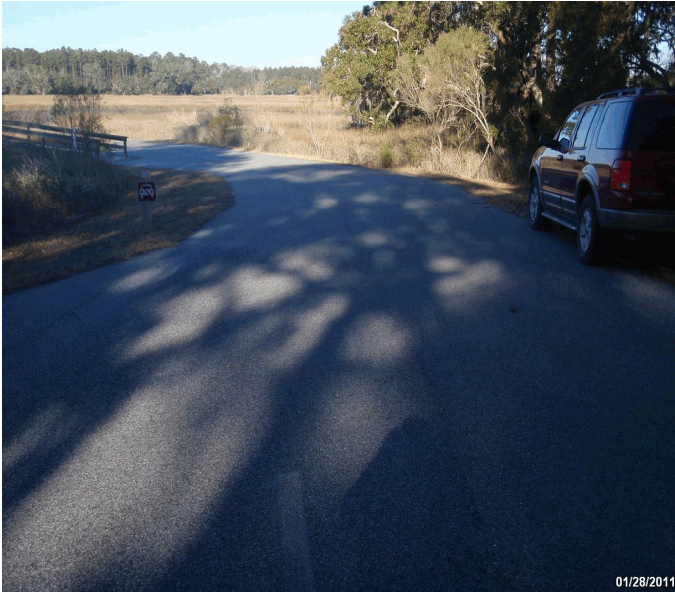
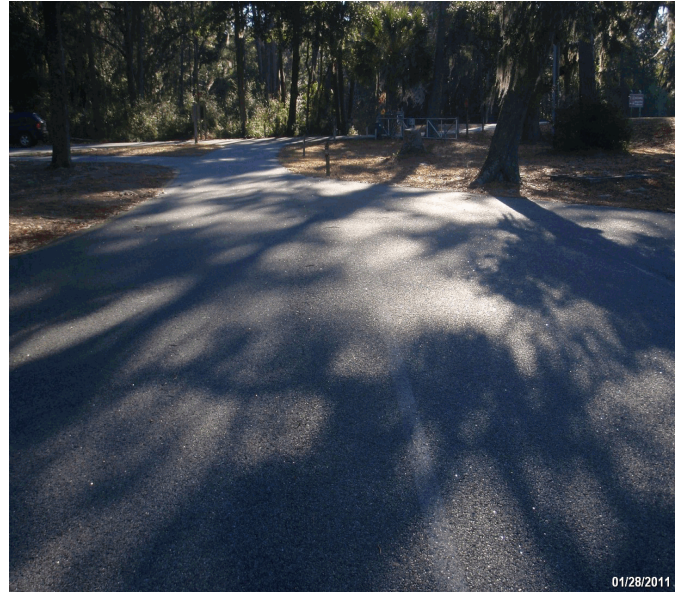
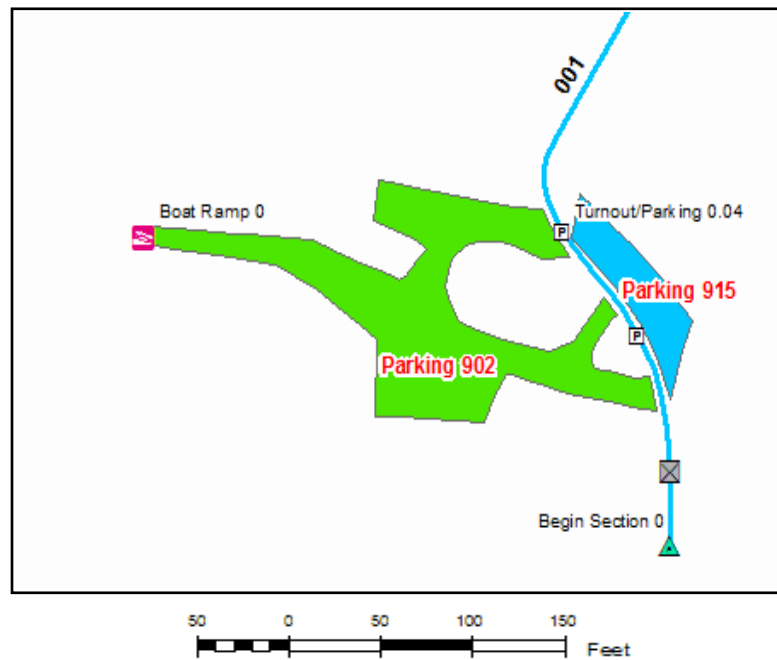
902: Entrance Boat Ramp Parking

Asset Number	Date Visited	Surface Type	Area (Sq Ft)	Condition	Cost to Improve
10037395	01/28/2011	Asphalt	14,221	Good	2,400

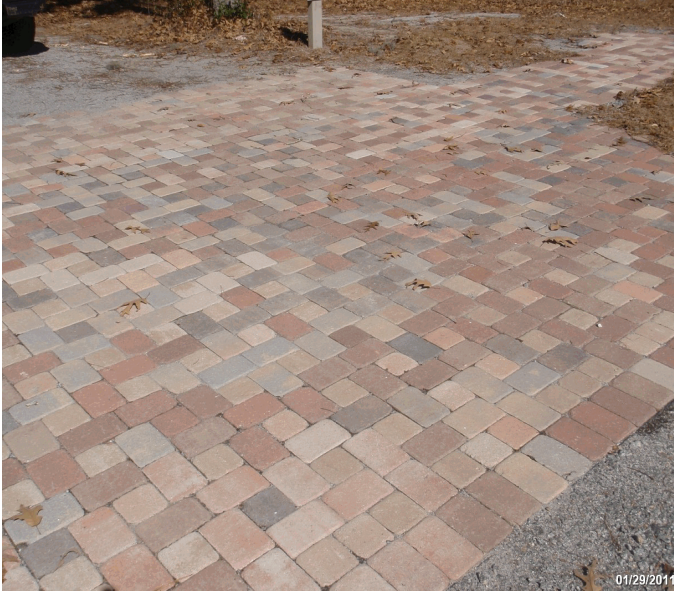
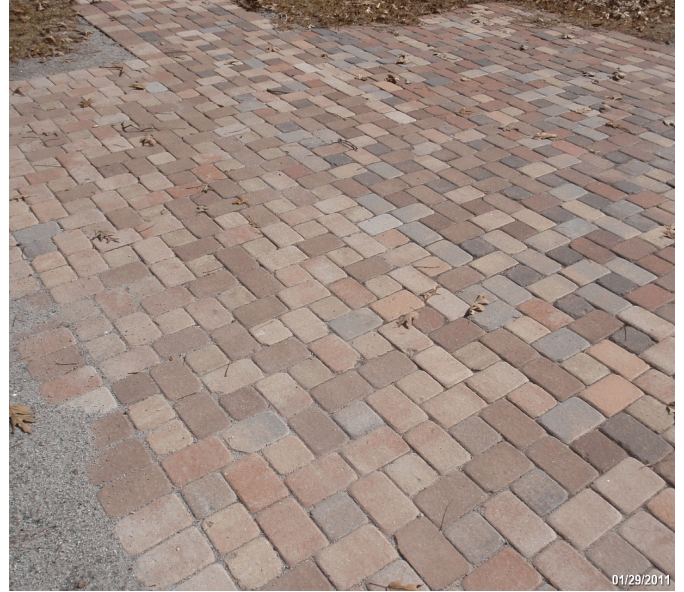
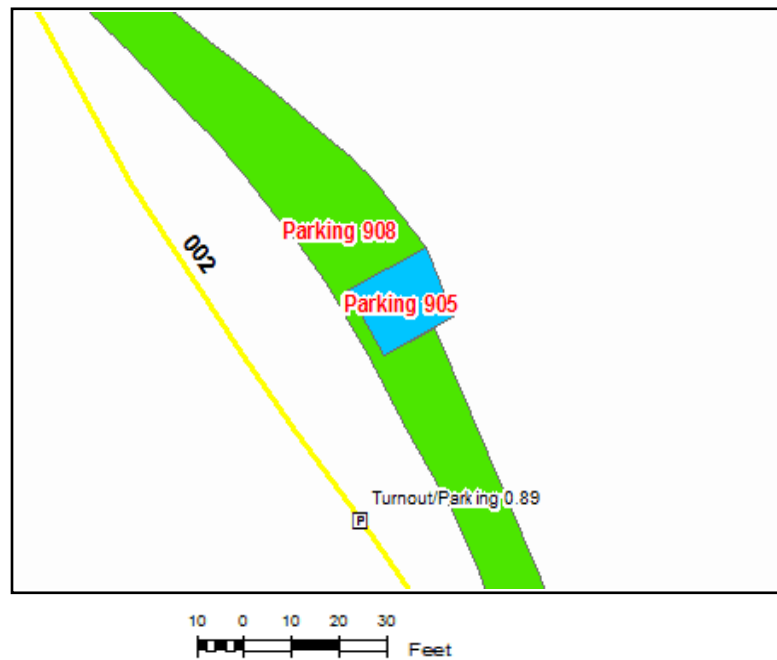
905: Woody Pond Handicapped Parking

Asset Number	Date Visited	Surface Type	Area (Sq Ft)	Condition	Cost to Improve
10037397	01/29/2011	Concrete	345	Excellent	0

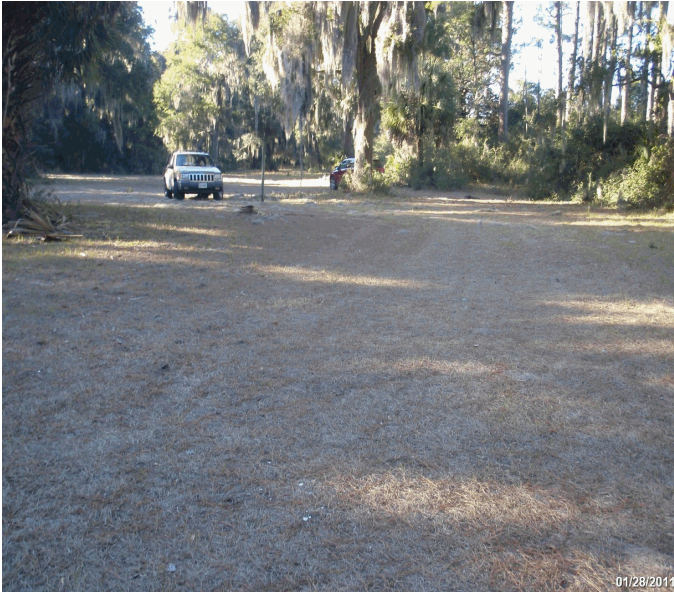
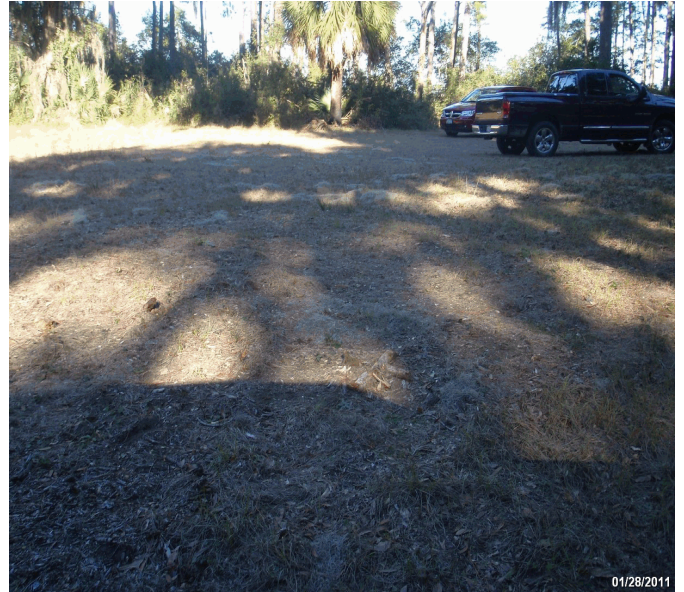
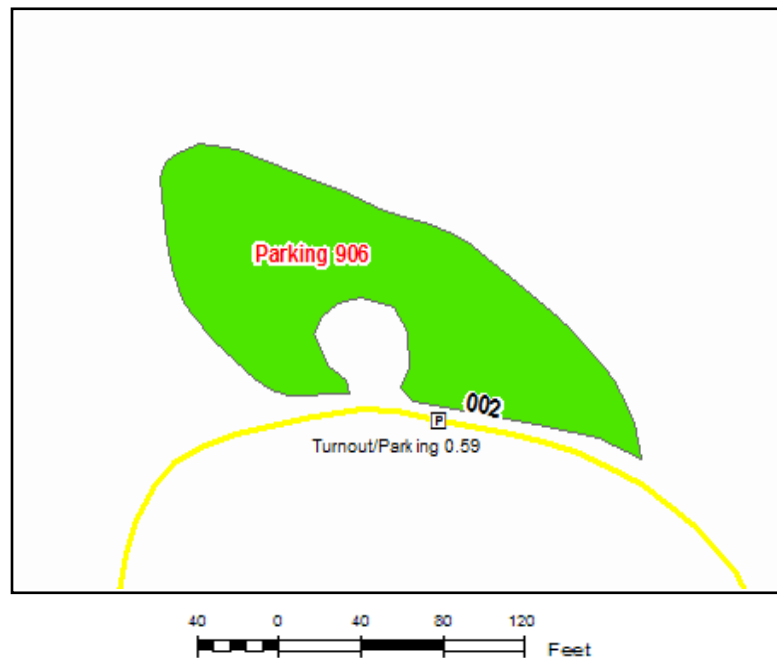
906: Thomas Landing Parking

Asset Number	Date Visited	Surface Type	Area (Sq Ft)	Condition	Cost to Improve
10037398	01/28/2011	Native	20,397	Good	2,800

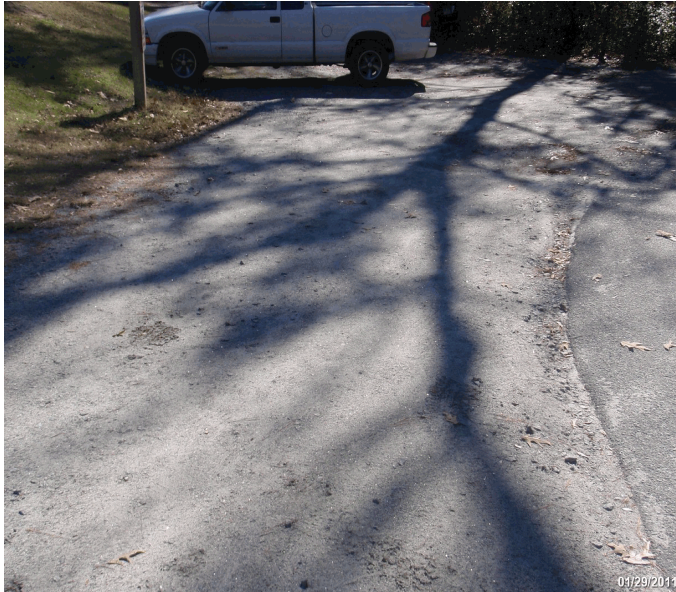
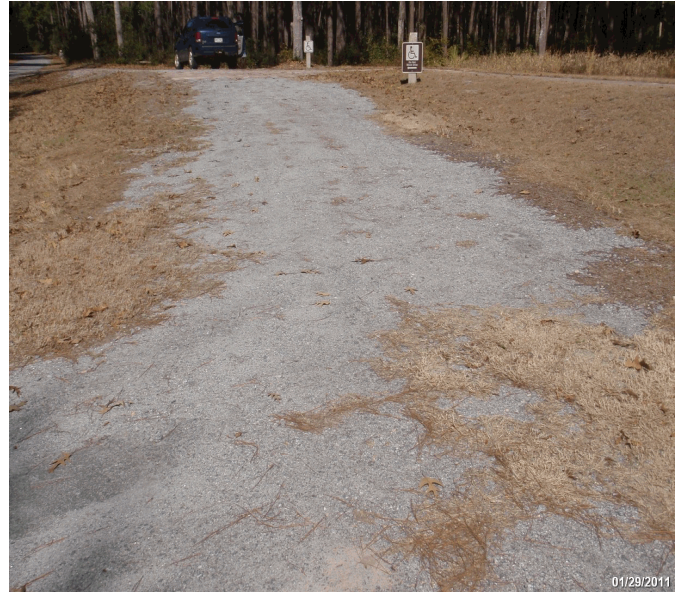
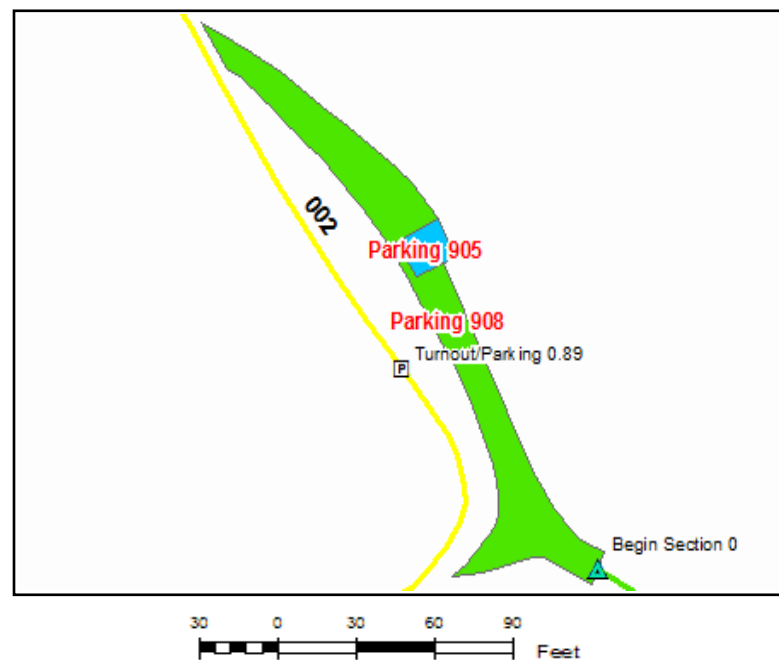
908: Woody Pond Parking

Asset Number	Date Visited	Surface Type	Area (Sq Ft)	Condition	Cost to Improve
10037400	01/29/2011	Gravel	4,719	Good	700

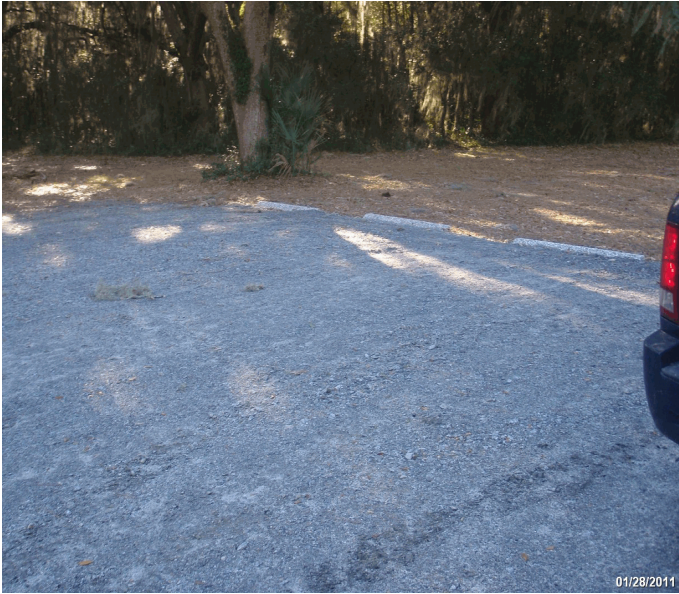
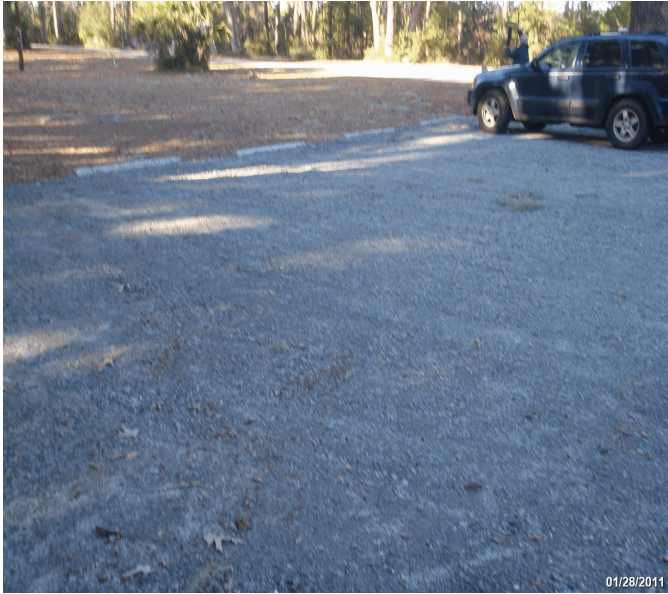
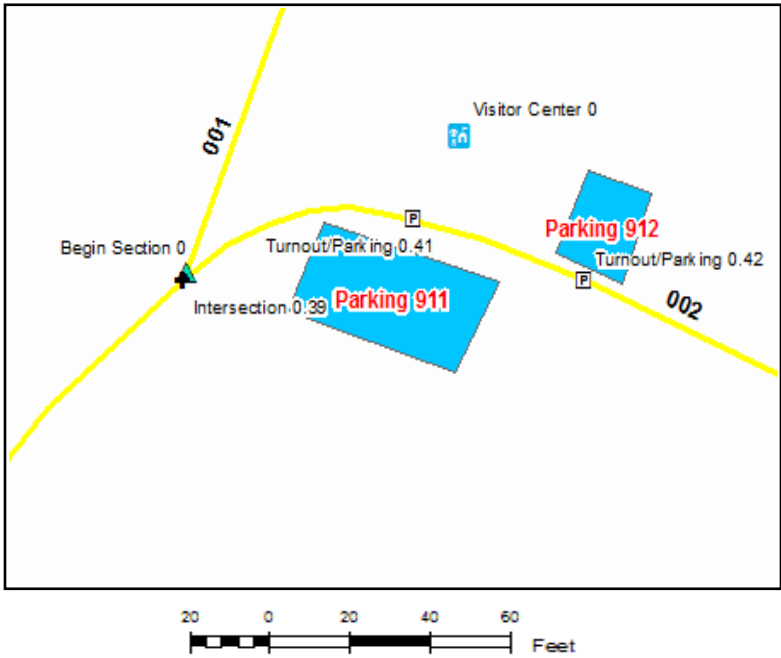
911: HQ/VC Parking

Asset Number	Date Visited	Surface Type	Area (Sq Ft)	Condition	Cost to Improve
10054747	01/28/2011	Gravel	1,377	Excellent	0

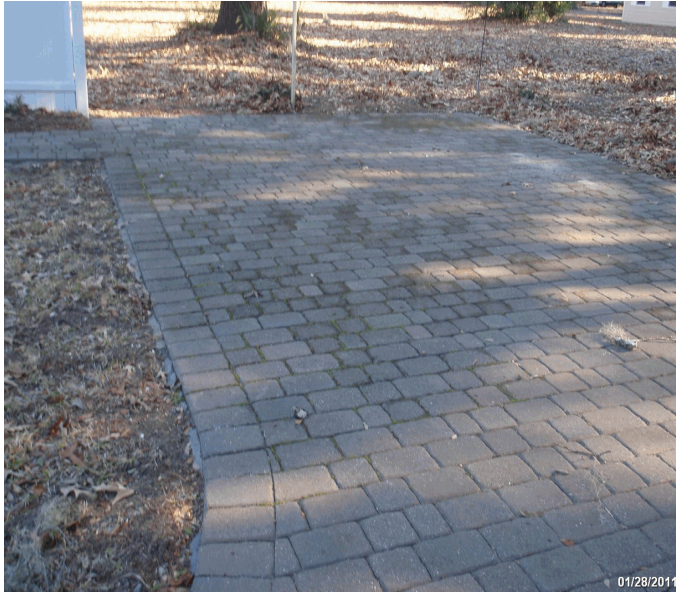
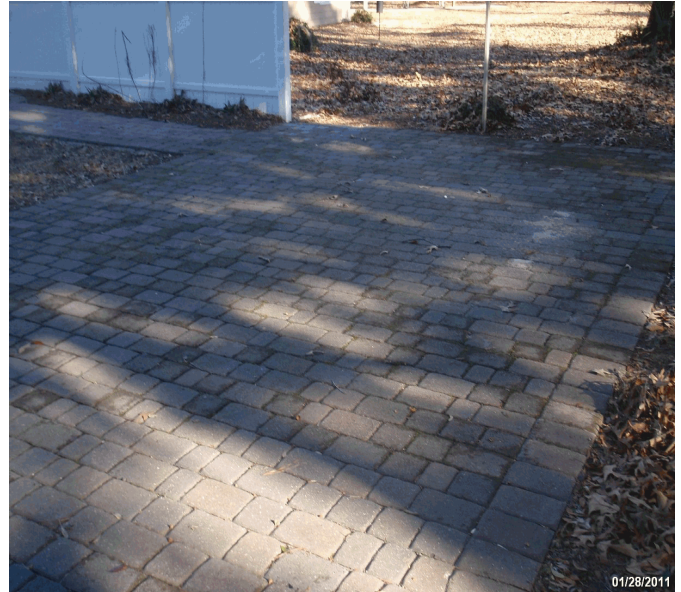
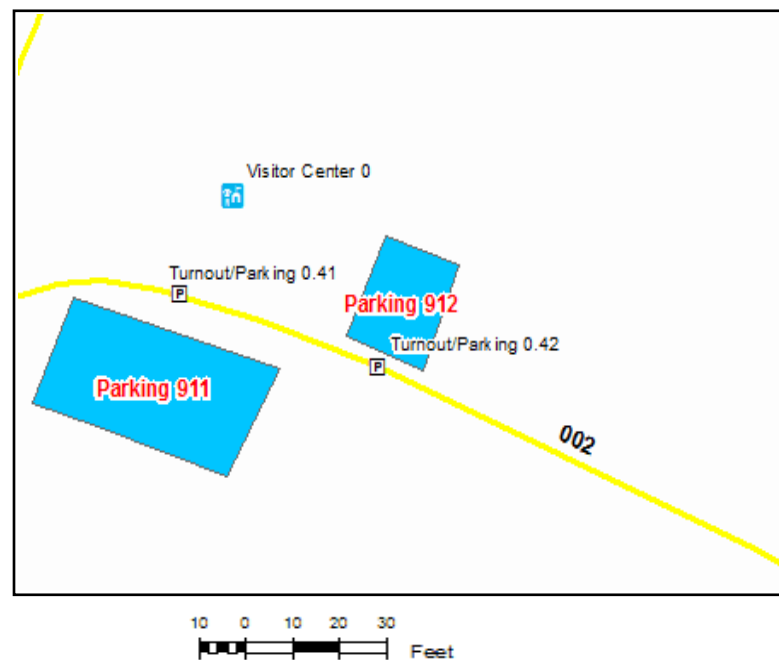
912: HQ/VC Handicapped Parking

Asset Number	Date Visited	Surface Type	Area (Sq Ft)	Condition	Cost to Improve
10054747	01/28/2011	Concrete	493	Excellent	0

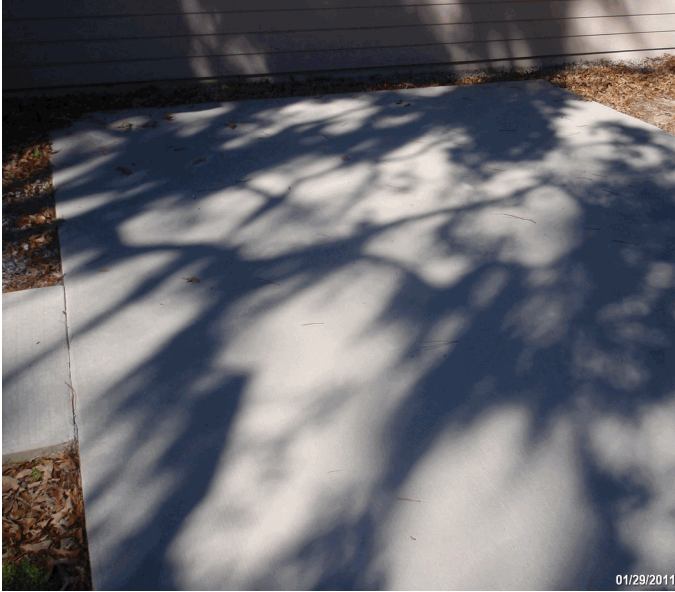
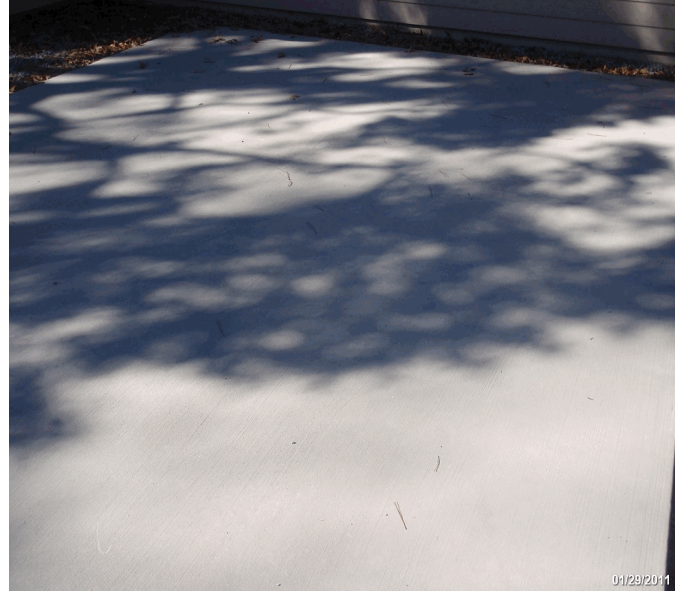
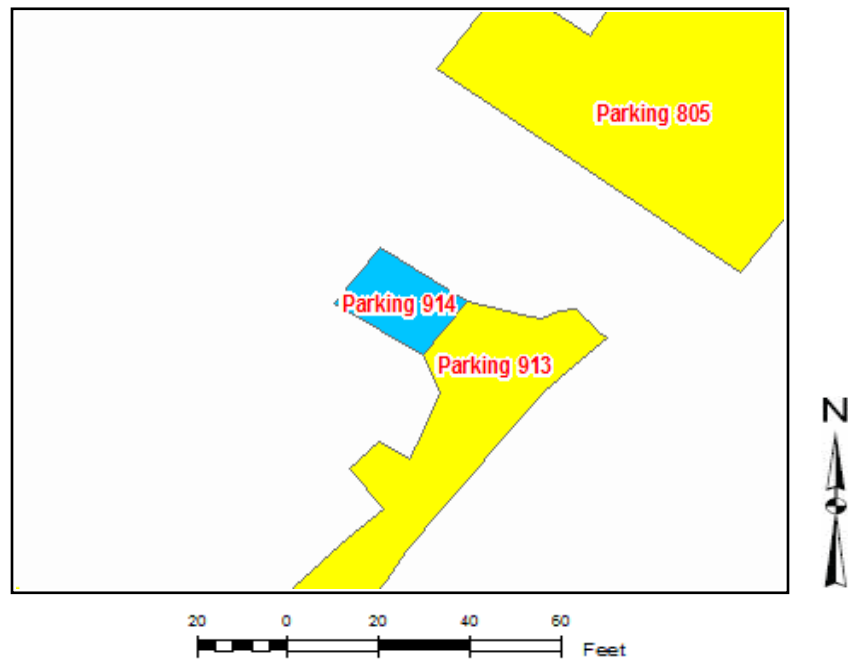
914: Ecological Services Office Handicapped Parking

Asset Number	Date Visited	Surface Type	Area (Sq Ft)	Condition	Cost to Improve
	01/28/2011	Asphalt	430	Excellent	0

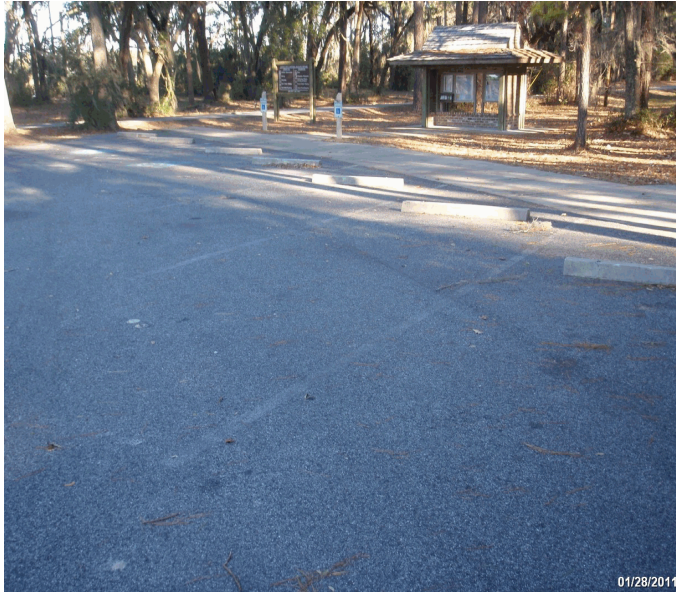
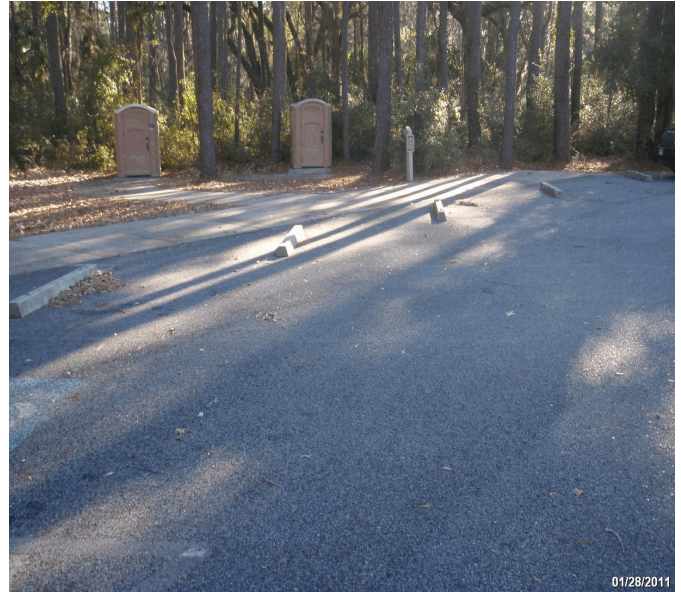
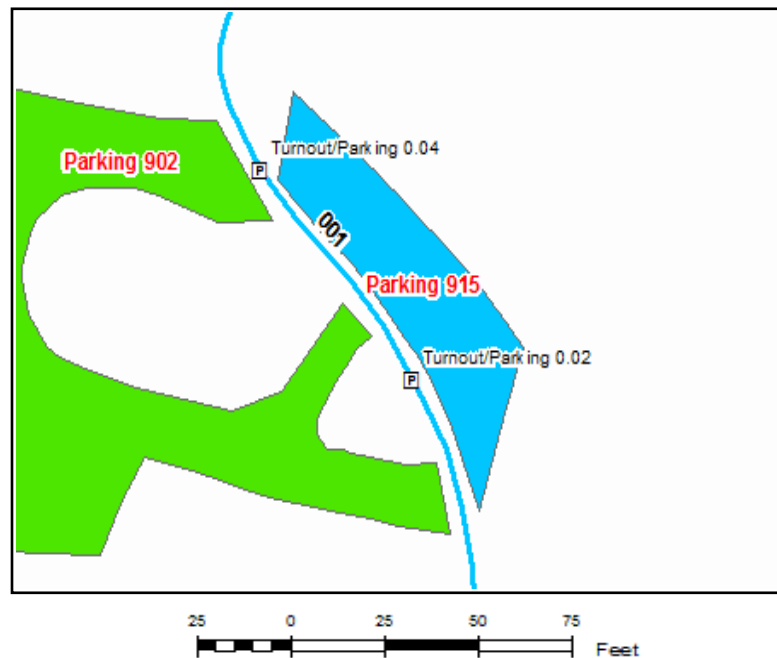
915: Entrance Kiosk Parking

Asset Number	Date Visited	Surface Type	Area (Sq Ft)	Condition	Cost to Improve
10037395	01/28/2011	Asphalt	2,761	Excellent	0
